Legionella Risk Assessment

Flat 6 10
Mavisbank Gardens
Glasgow
G51 1HG

Reference: 005840

Assessment date: 07/02/2023

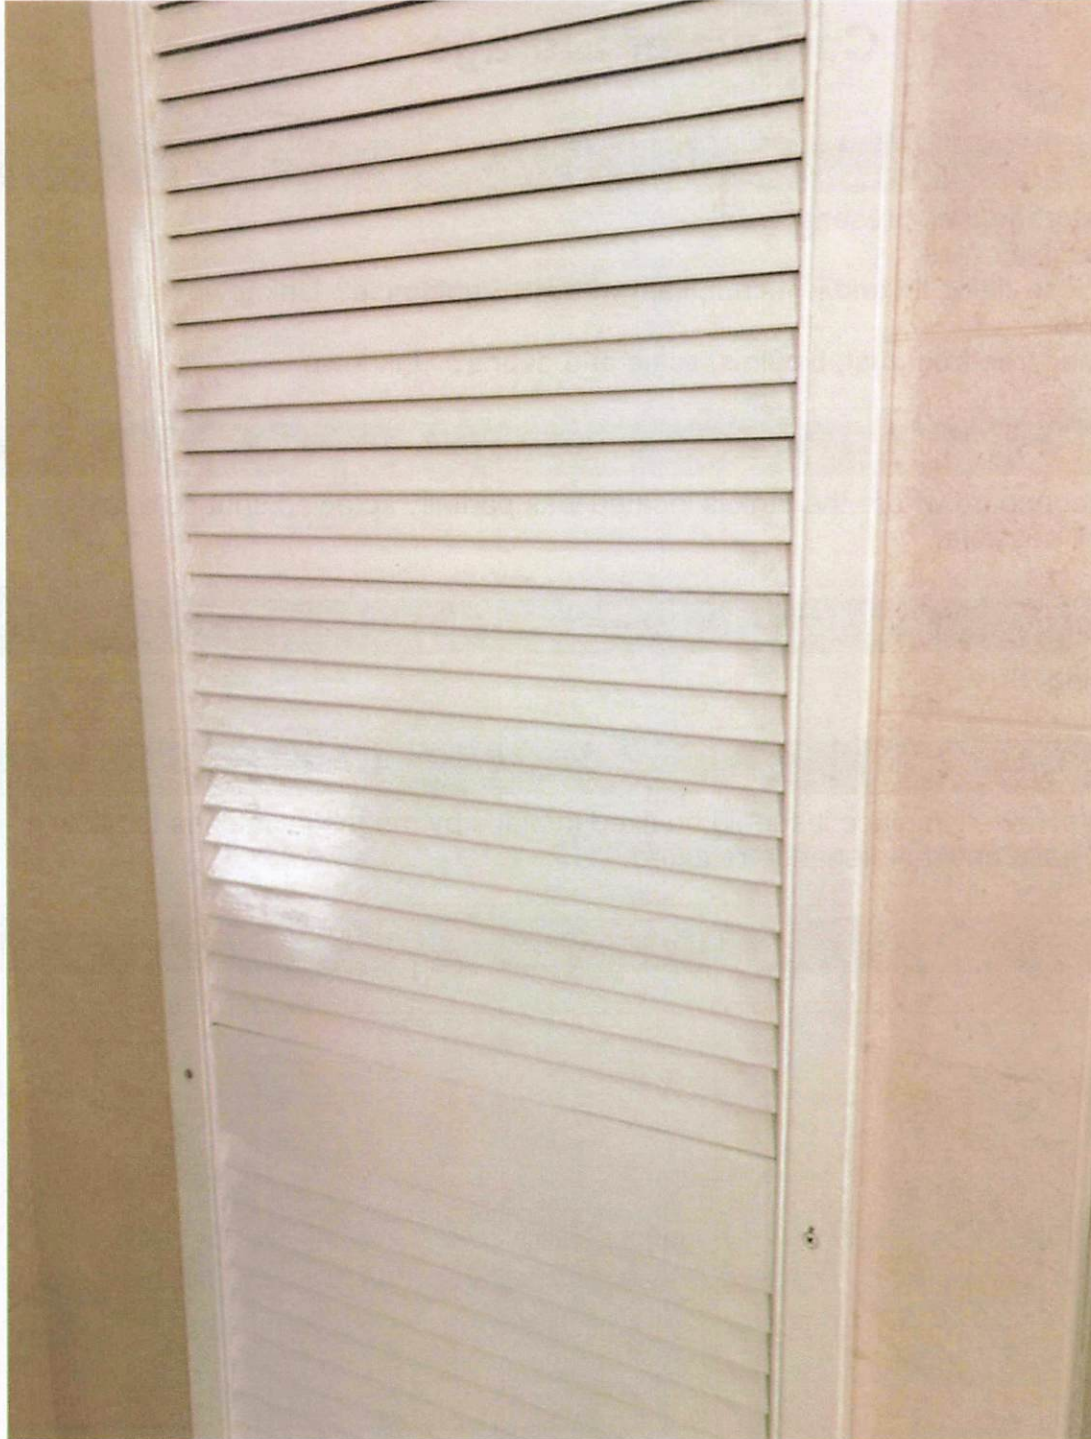
Photo of cold water storage

Is it insulated? No

The door to the cupboard where the tank is located was partially screwed shut so a full inspection wasn't possible.

Risk level 1 - Minor

The door not be screwed in place it should be fixed in place by magnetic catches to allow a full inspection & ease any maintenance required.

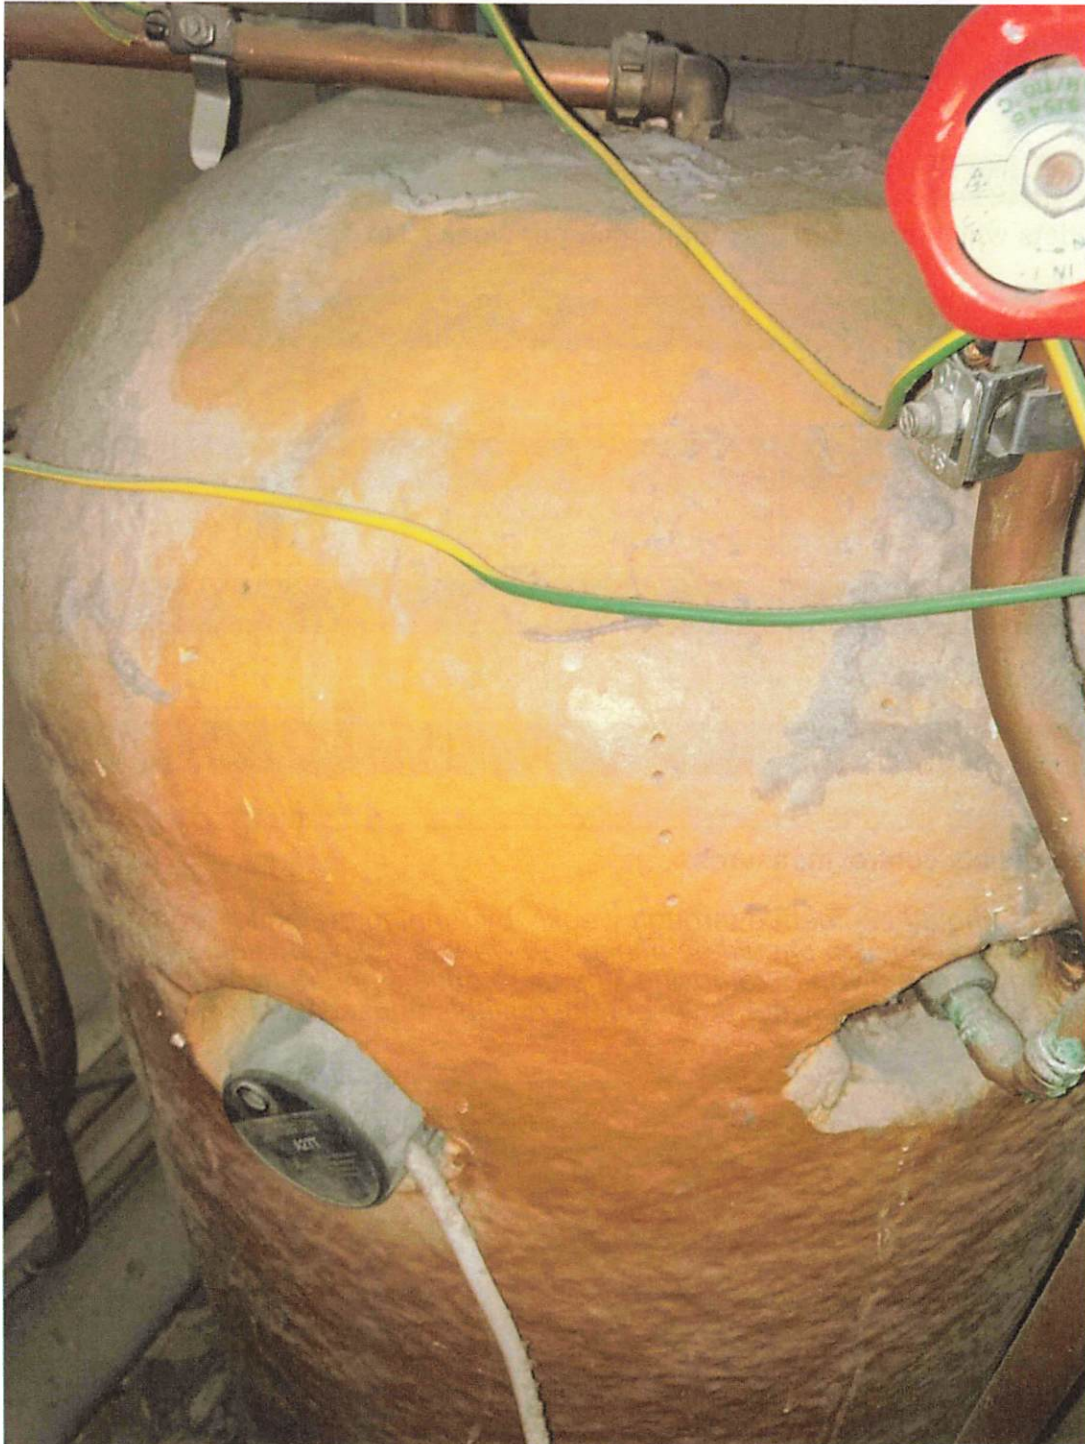
Photo of hot water storage

Is a hot water cylinder present? Yes

Is the cylinder insulated? Yes

Is a cylinder thermostat present? Yes

Is the temperature of the flow pipe 60°C or above? No

Does the overflow from the calorifier go to a tundish or drain? No

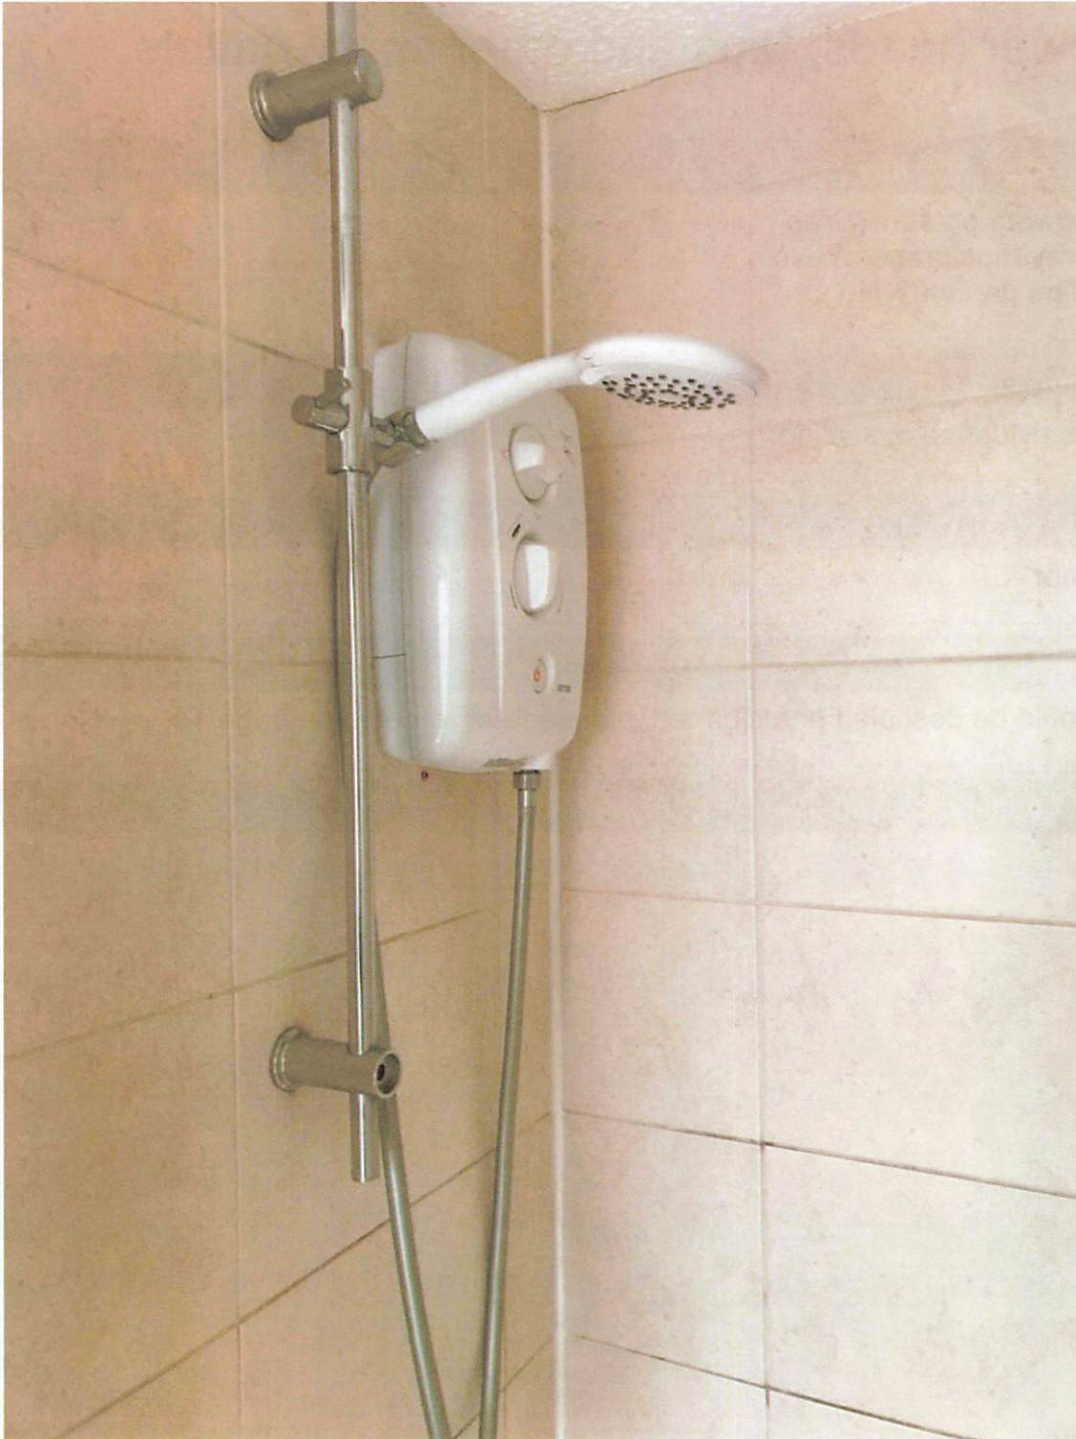
Photo of Shower heads, taps and other spray outlets

Shower head has evidence of scaling.

Risk level 1 - Minor

Shower head should be descaled and cleaned, please refer to notes on page 14.
